ARMAMENT RESEARCH AND DEVELOPMENT
ESTABLISHMENT

A.R.D.E. REPORT (S) 26/55

Investigation of Accidental Explosion of 1000 lb.
Bomb at R.A.F. Station Marham

October
1955

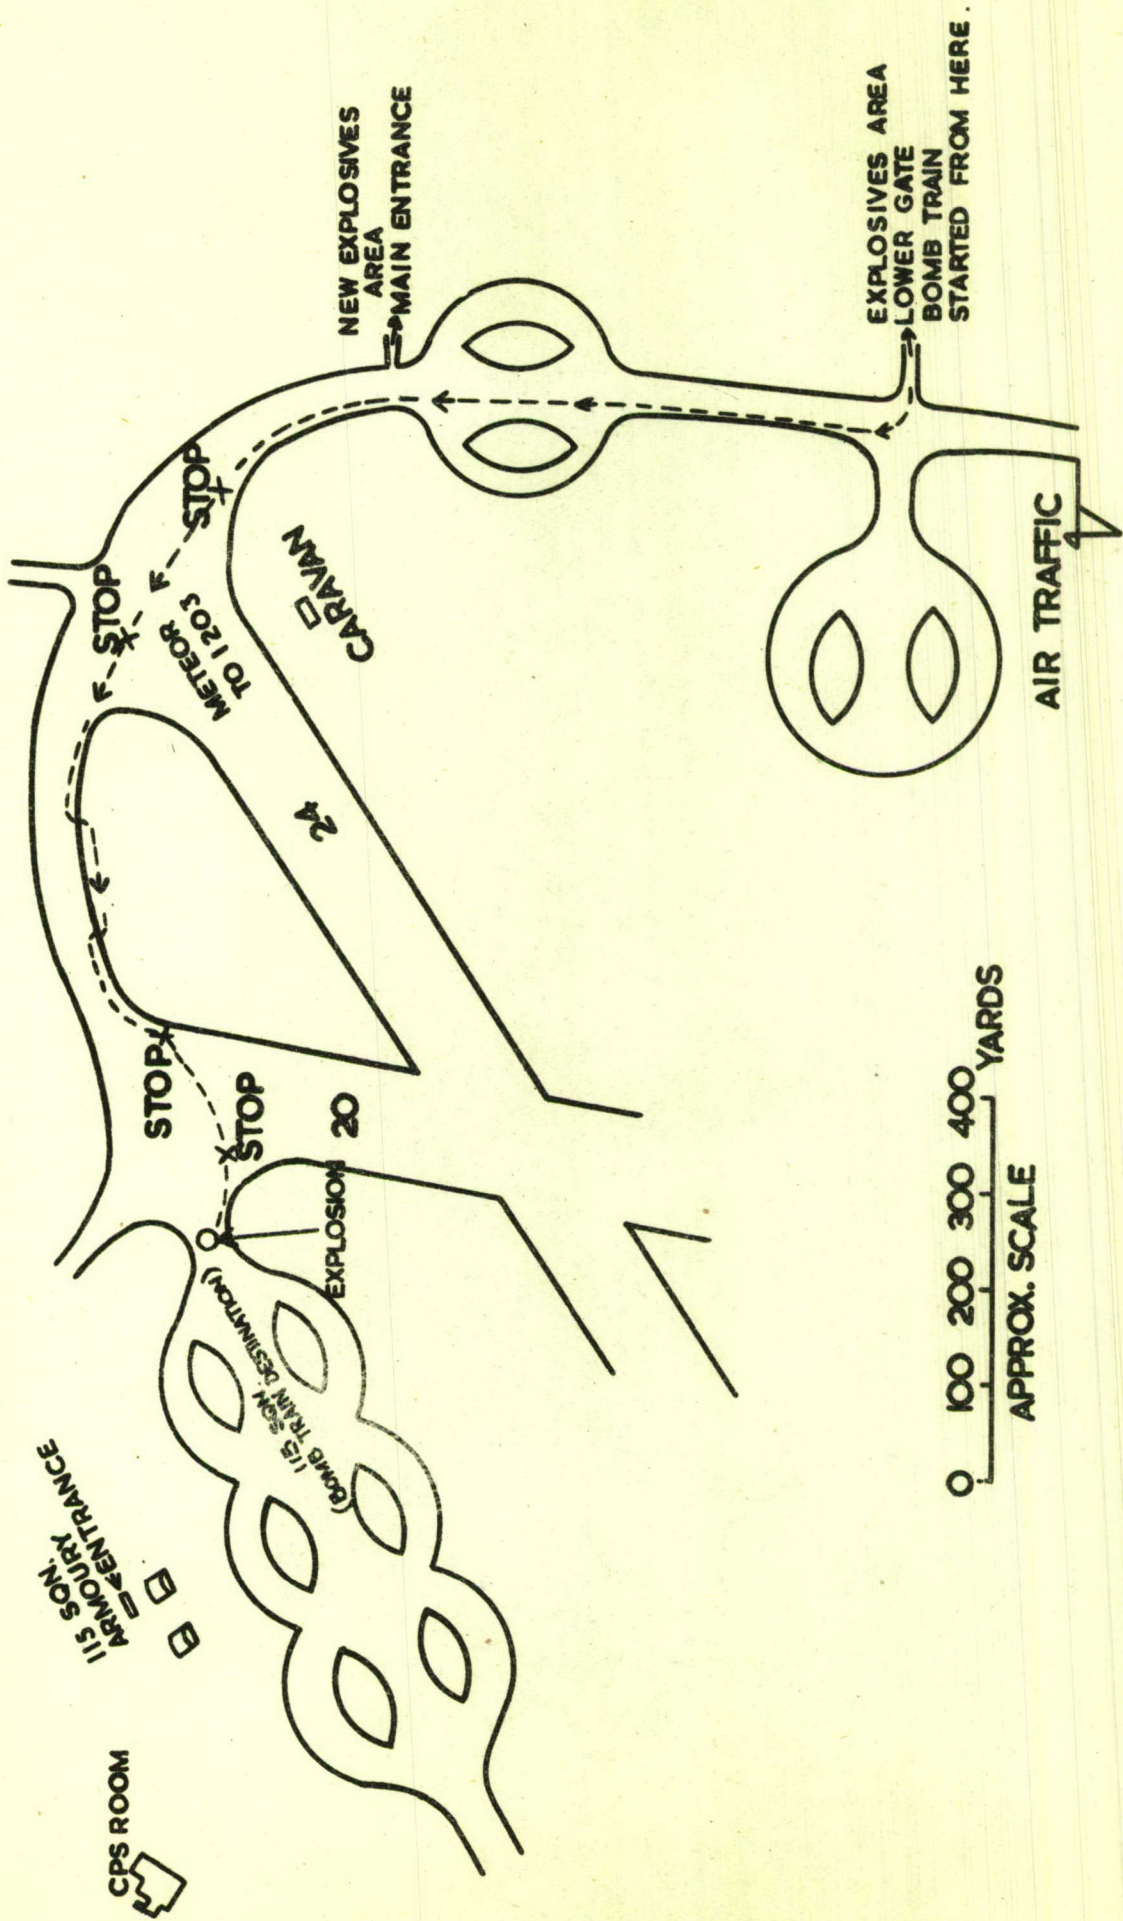
FIG. 1 GROUND PLAN OF BOMB INCIDENT, MAR. 28 46 2ND OCT. '54

"At 12.00 hours on 20.9.54 a tractor towing two loaded bomb trolleys was being driven from the explosive area towards No.115 squadron dispersal area. The route of the tractor is shown in Fig.1. There were four bombs on the forward trolley and two in the rear position on the rear trolley. About three quarters of the way across runway 24 the tractor stopped for about 30 seconds and then carried on. About 50 yds. beyond runway 24 the driver took the bomb train on the grass for an unknown period, then returned to the perimeter track. The rear bombs were noted at this point by the Station Commander as having moved slightly but not to a dangerous position. The driver continued on the perimeter track until entering runway 20 where he stopped and got down to examine the bombs on the trolleys. He then drove very slowly across runway 20 and stopped again on the other side. At this point the bombs were observed on the rear trolley, by an aircrew member, to be off the trolley cradles. The driver started slowly toward 115 squadron dispersal when an aircraft had passed and had reached a position about one third of the distance across the perimeter track when there was an explosion (12.08 hours). Four unexploded bombs were found in the area." (photographs 7 and 8).

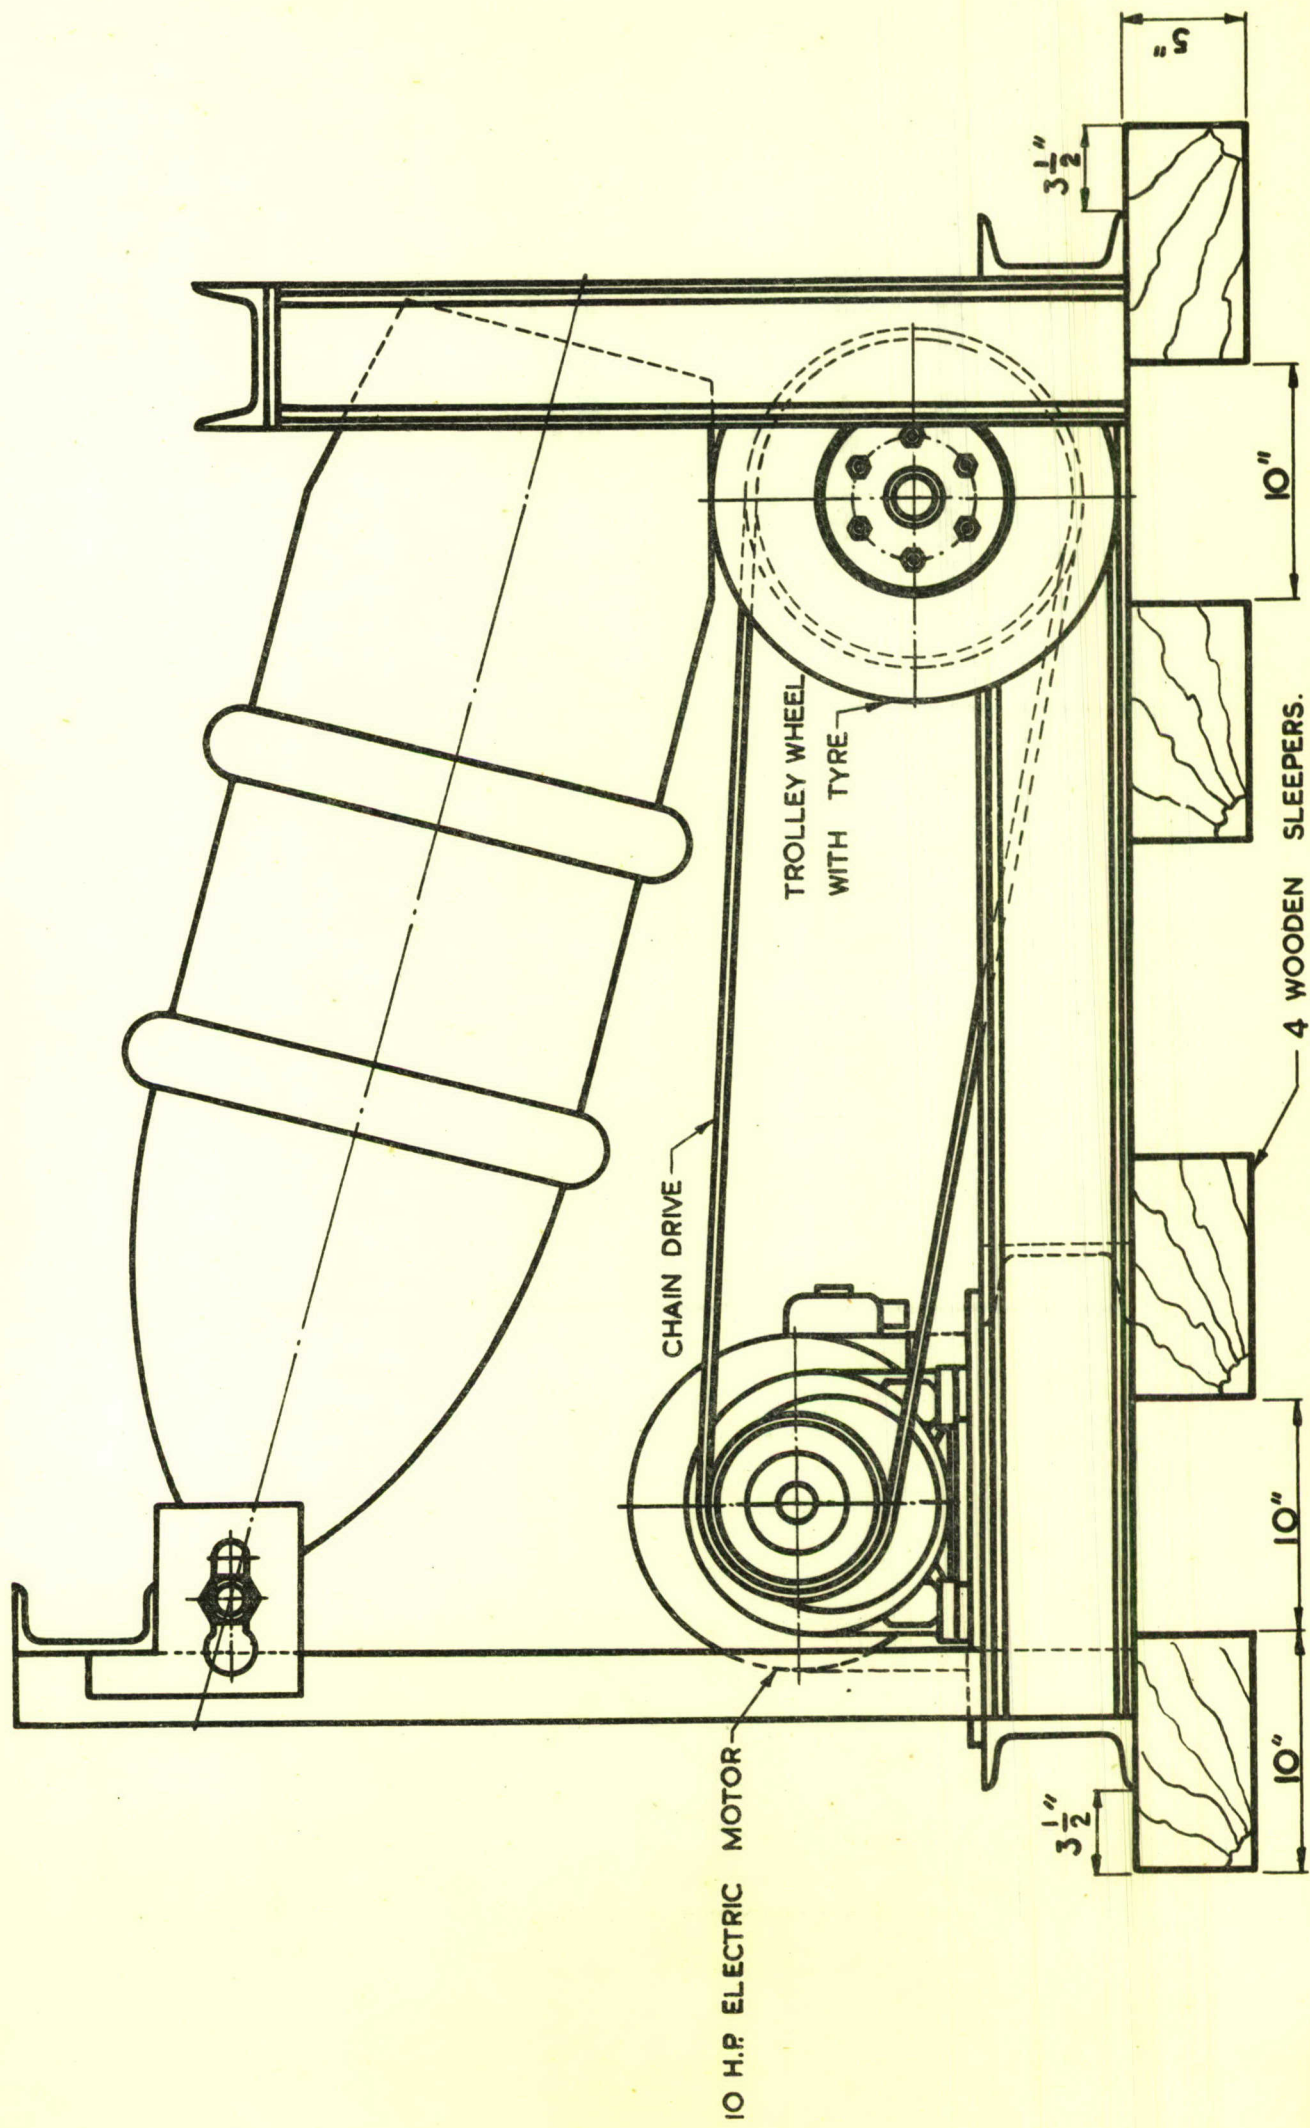
FIG. 17. TRANSMISSION TEST UNIT.

A framework was constructed (Figure 17) on which a 1000 lb. bomb could be suspended by the nose so that the weight of the rear portion was taken on a tyred trolley wheel. The trolley wheel could be rotated by an electric motor either at 130 or 260 r.p.m., corresponding to a ground speed of 6.7 or 13.5 m.p.h. The bomb was prevented from bouncing off the wheel by angle girders, and from axial rotation by fixing the lug.

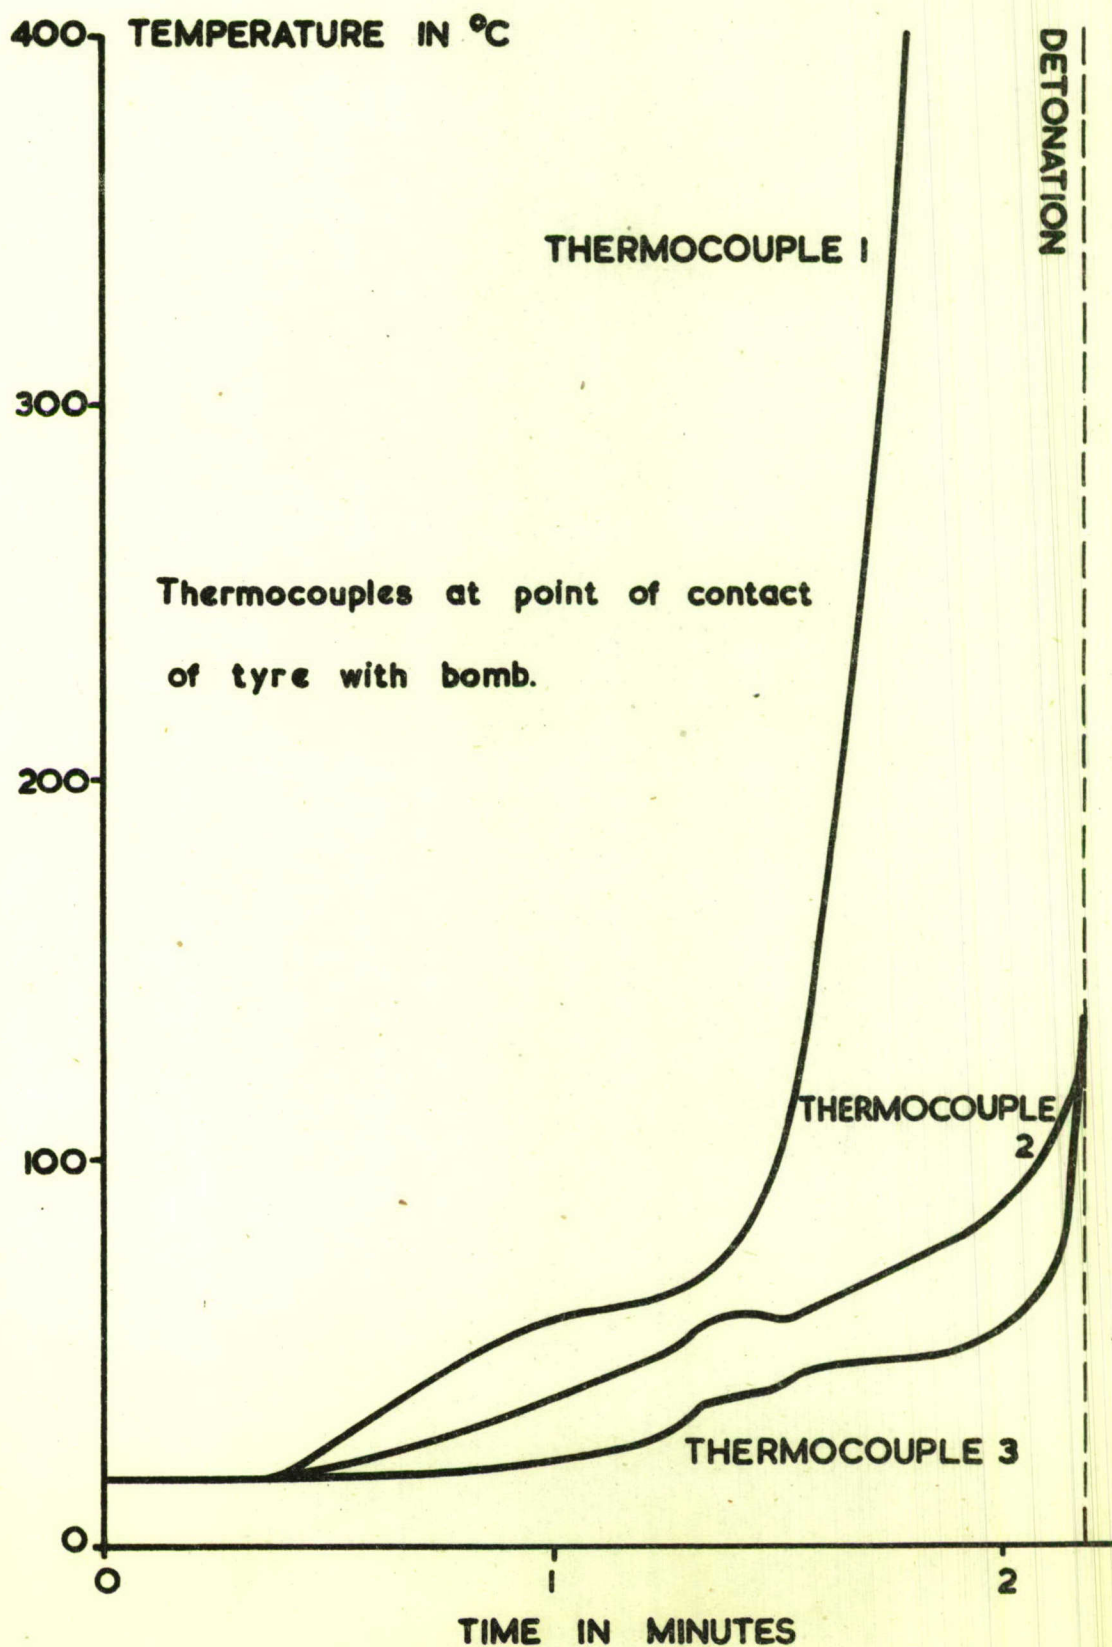
The temperature rise shown by the thermocouples was plotted and is shown in Fig.19. A first straight portion occurred while the mud was being removed from the tyre. The characteristic drop in temperature occurred after approximately one minutes effective heating, at an unusual low temperature which indicates that thermocouples 2 and 3 were not in the region of maximum reaction. Thermocouple 1 showed no drop in temperature and the rapid rise suggests that this thermocouple was in contact with the bomb wall at the region of maximum temperature and that the explosive melted away, leaving it surrounded by an air or gas pocket. The temperature subsequently recorded was that of the bomb wall due to friction plus heat of decomposition rather than that of the explosive.

FIG.19 FULL SCALE FRICTION TRIAL.

FIRESTONE BOMB TROLLEY TYRE ROTATING AT
132rpm. AGAINST 1000lb., MC Mk VII BOMB FILLED RDX./TNT.

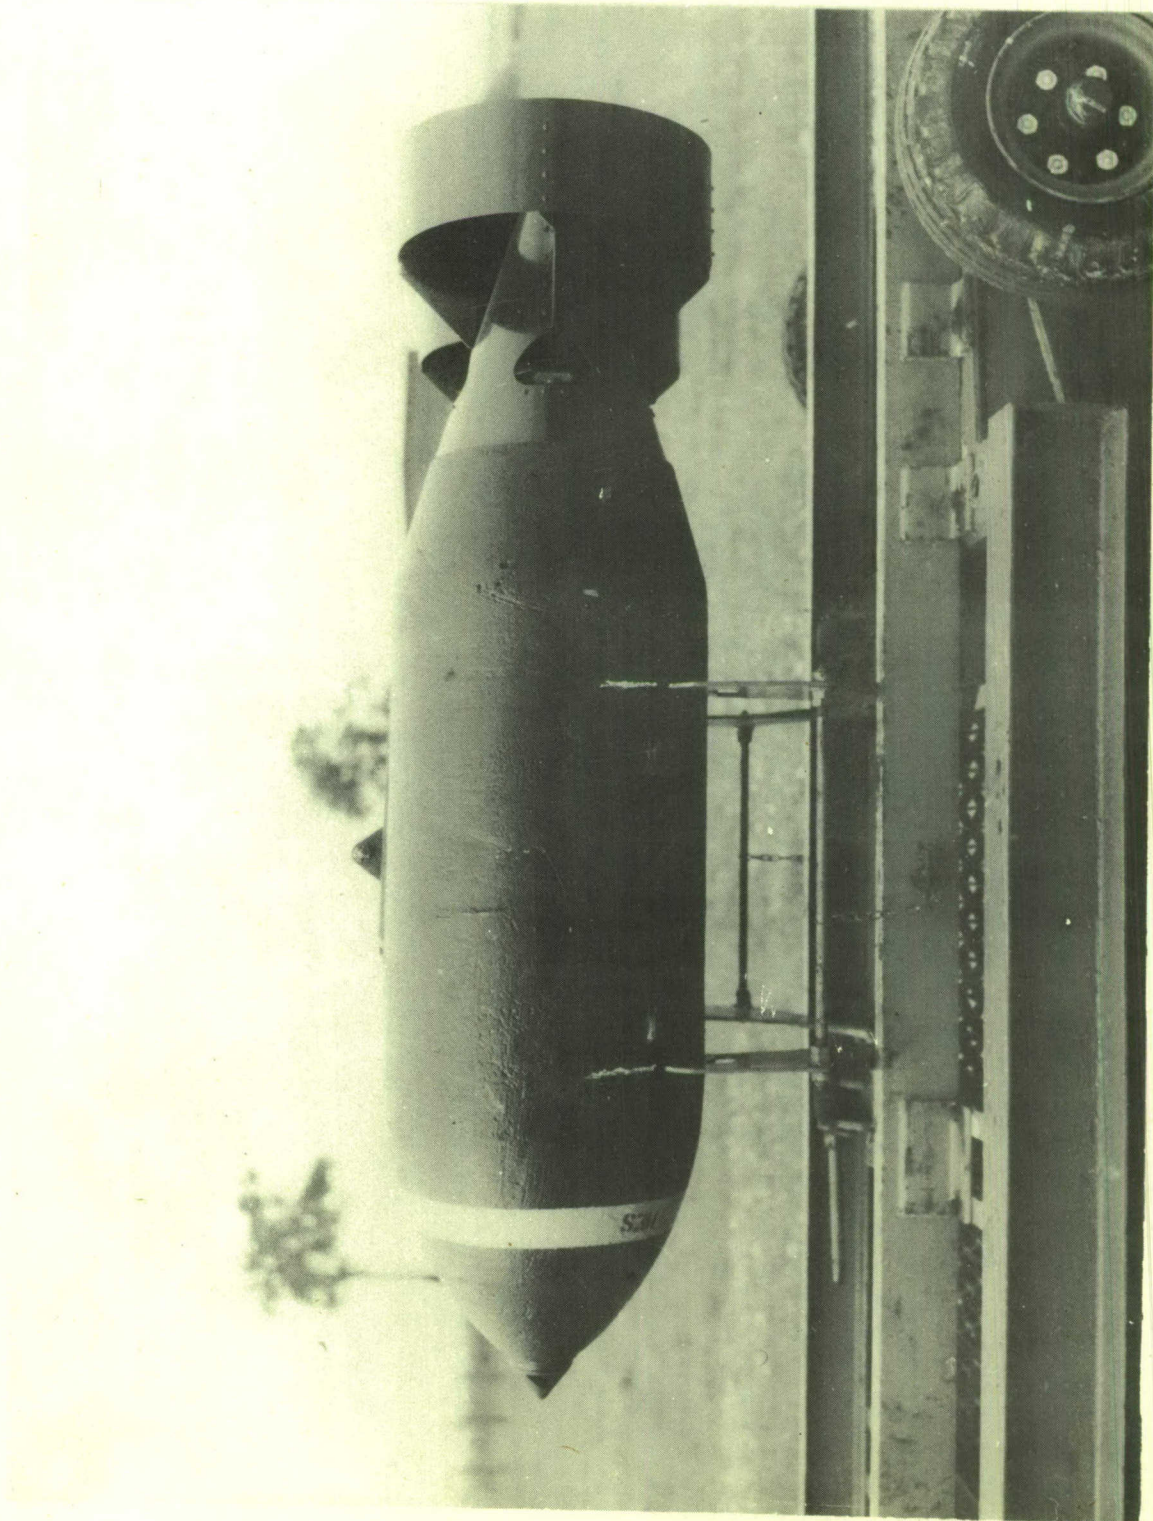
The remains of the bomb trolley were examined. The force of the explosion was directed mostly forwards, the trolley rails and main frame members being twisted outwards and slightly downwards. These rails and main frame were intact up to a point which would be beneath the centre of the bombs when resting normally (photograph 6), but the rear portions could not be identified. The right hand side of the rear axle was recovered from the crater showing signs of an explosion above it. The left hand side was not recovered. The damage is consistent with the explosion of a bomb displaced from the cradle and resting above the rear axle rather than with the explosion of a bomb in its correct position. The two positions are shown in photographs 9 and 11.

That such a displacement of bombs on a trolley is easily possible was demonstrated at Marham. With only two bombs on the cradle of the trolley slight jerking started the bombs moving backwards. (photographs 9 and 10). As the centre of gravity of the bombs moved back this tendency increased until the bombs slipped from the cradle and came to rest on the framework of the trolley (photograph 11). The bombs came to rest in one of two ways. In both cases one bomb was resting with the base on the towing hook, the nose on the back upright of the cradle, and most of the weight being taken by the frame. The other bomb would fall either outside the rear wheel (photograph 12) or on the tyre of the rear wheel (photograph 13). If it fell outside the rear wheel, the tail of the inside bomb dragged on the ground, the wheel pushed the outside bomb forward and the force exerted could break the carrier (photograph 14). If it fell on top of the rear wheel a stable condition was set up, the tyre rubbing on the bomb (photograph 15). In this position towing could proceed without noticeably affecting the ease of movement. In the trials at Marham it was found that the Mark 7 bombs normally fell in the latter manner. Converted Mark 2 bombs, owing to the remains of the welded lugs present, were more difficult to shake off and usually fell in the first manner.

9. Bombs in normal position on cradle of trolley

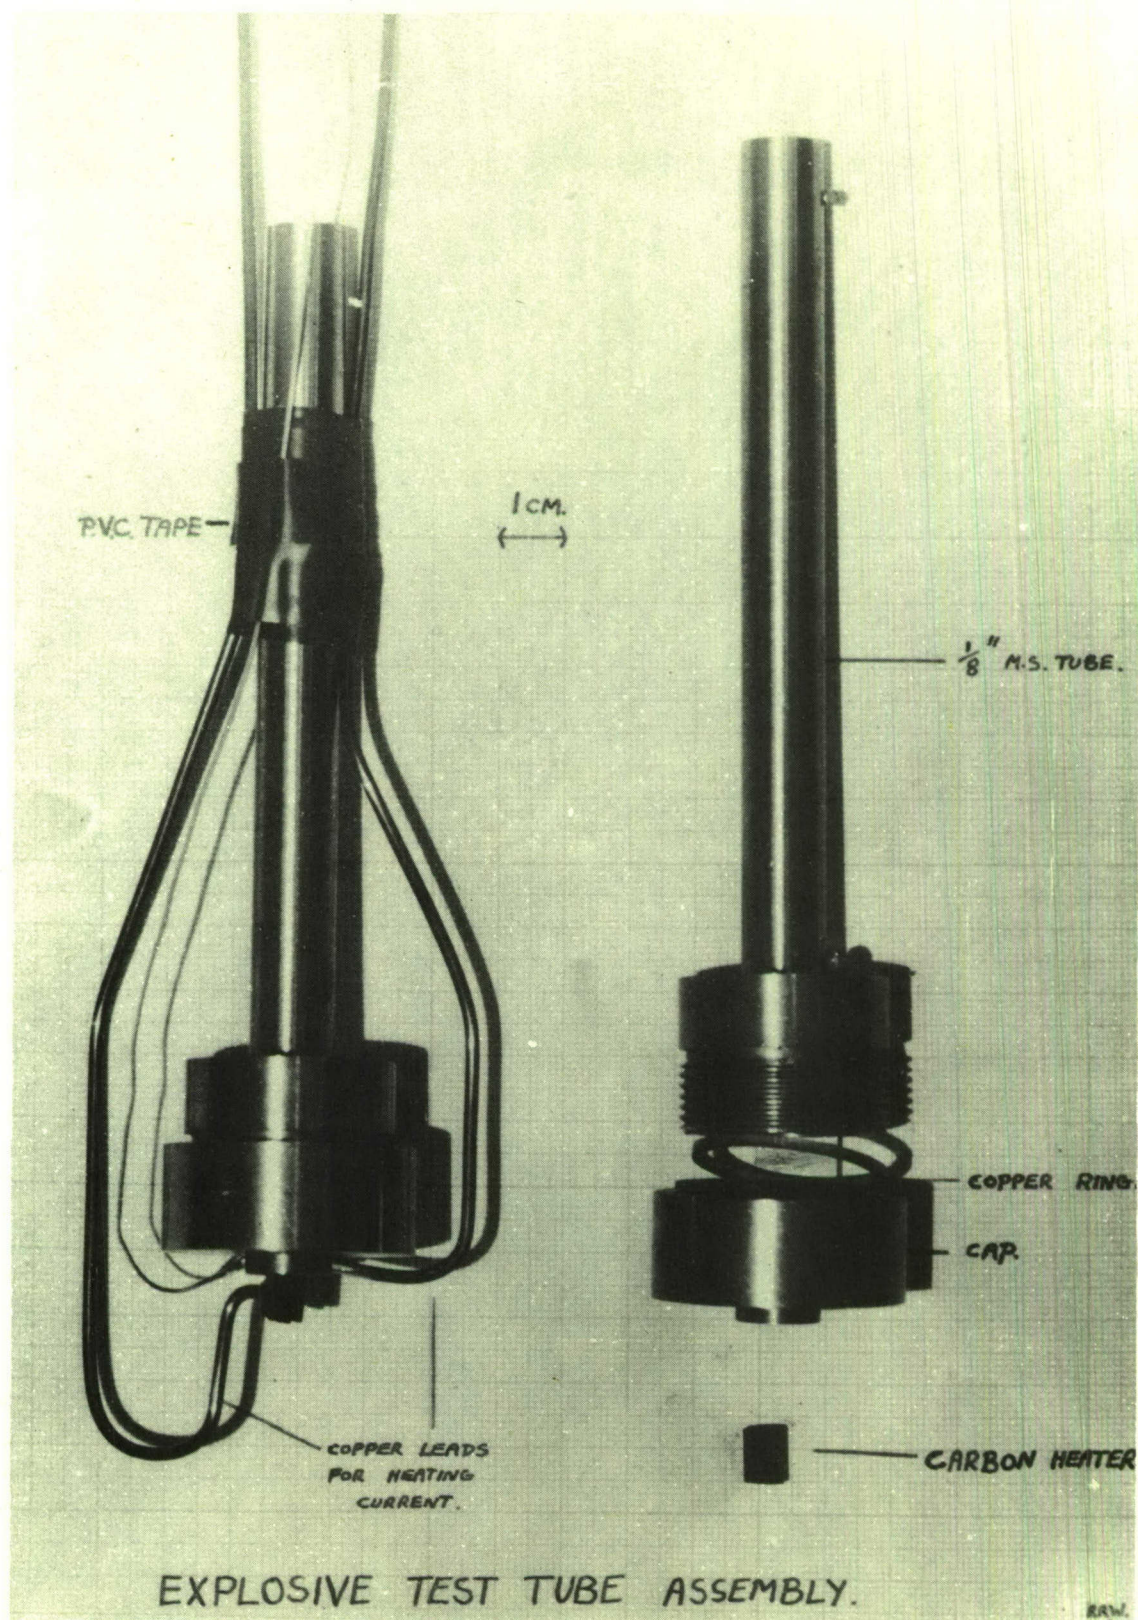
22. Tubes used for small scale heating trials of RDX/TNT

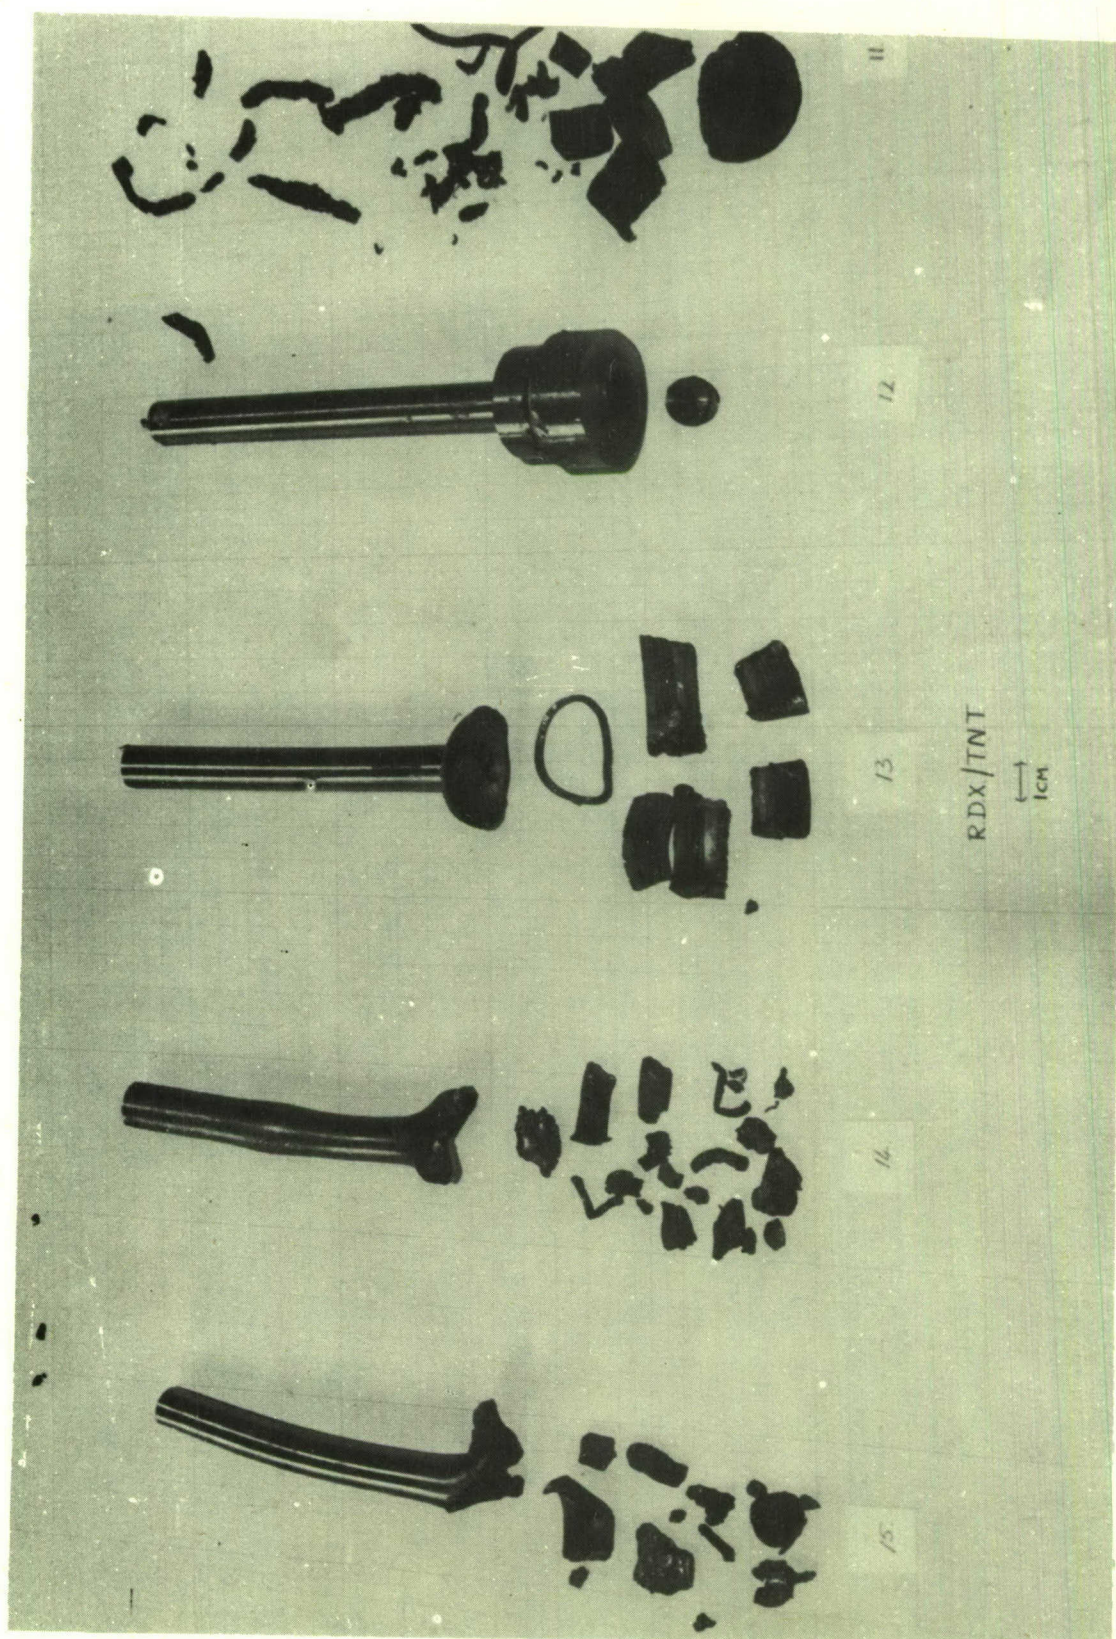
23. Fragments from small scale heating trials of RDX/TNT

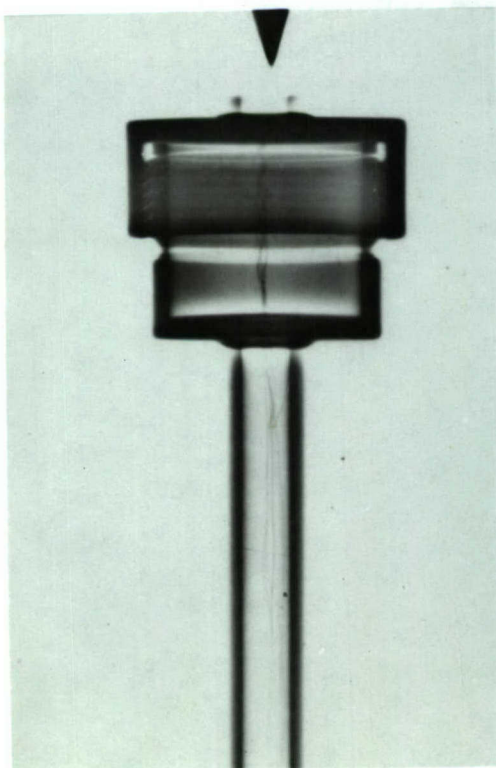
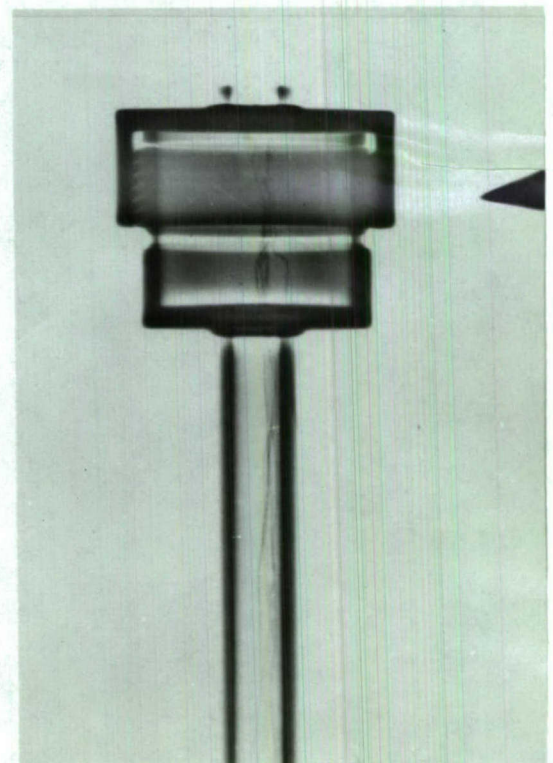
A further trial was carried out in which the position of four thermocouples was determined by radiography (photographs 25, 26). The first thermocouple (A) was in the steel tube below the heater as before, the second (B) was inside the tube at the surface of the explosive, the third (C) and fourth (D) 1/8 in. and 1/4 in. below the surface. The temperature record for this trial is shown in figure 11. After 13.75 minutes a partial detonation occurred. The energy input was maintained at a constant value during the trial and it was observed that both thermocouples B and C showed a marked decrease in temperature after approximately 10 minutes heating. Thermocouple D, the temperature of which lagged well behind, did not show this decrease. This type of curve is repeatable, and it was found that after this decrease, the rate of rise of thermocouple C was much greater than would be accounted for by the external heat input. The suggestion is that the discontinuity in the curve indicates the commencement of decomposition of the explosive filling under the particular conditions and that this decomposition increases in vigour until an explosion or detonation occurs.

25. X-ray photograph showing thermocouple in small scale heating trials of RDX/TNT

26. X-ray photograph at right angles to Fig. 25
